**SITE ASSESSMENT REPORT  
FOR  
SALESIAN PREPARATORY SCHOOL  
CEDAR LAKE, INDIANA  
TDD: T05-9405-015  
PAN: EIN0821SAA**

**May 19, 1994**

DATE: May 19, 1994  
TO: Ms. Gail Nabasny, U.S. EPA, TAT DPO  
CC: William Simes, U.S. EPA OSC  
FROM: Michael Mangini, TAT  
SUBJECT: Salesian Preparatory School  
Cedar Lake/Lake County/Indiana  
TDD # T05-9405-015  
PAN # EIN0821SAA

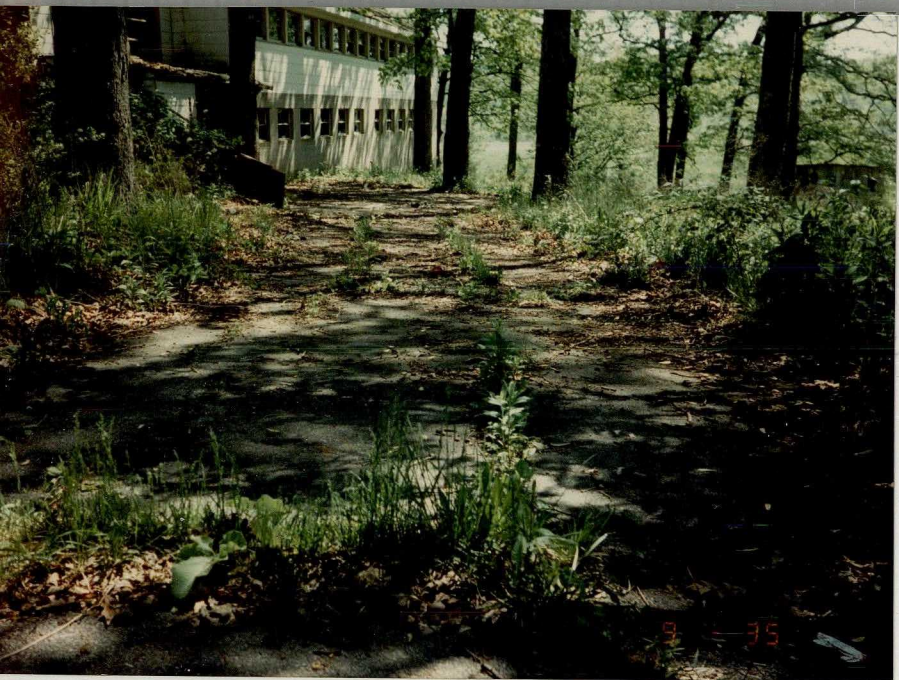
Site: Salesian Prep  
Photo No.: 1 Date: 5/16/94  
Camera: OLYMPUS INFINITY 35mm  
Photographer: Lisa Gracyzk  
Direction: South  
Subject: Road leading to chemistry  
storage building.

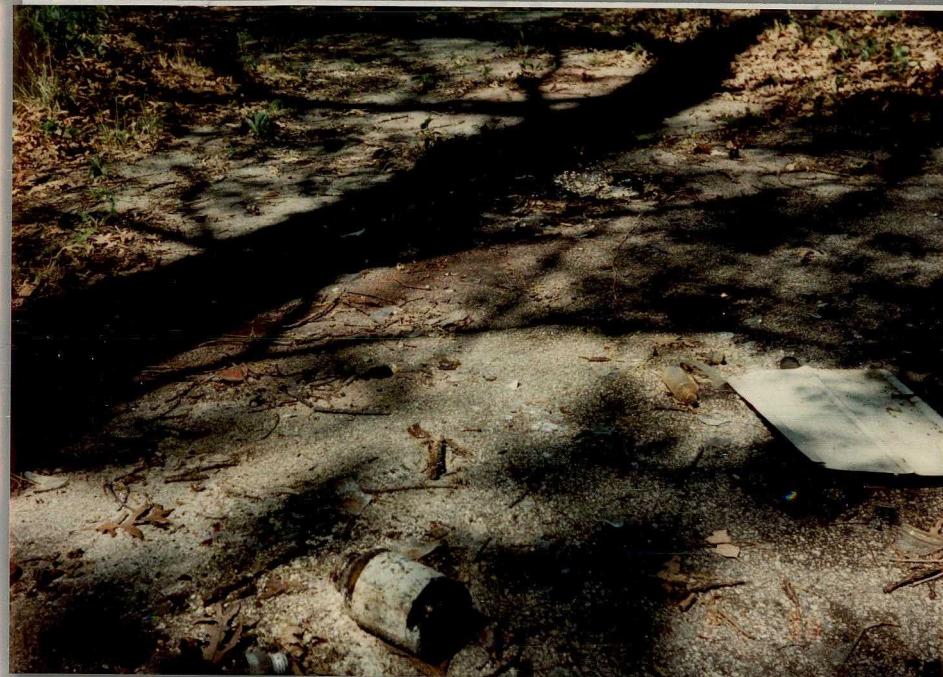
Site: Salesian Prep  
Photo No: 2 Date: 5/16/94  
Direction: South  
Camera: OLYMPUS INFINITY 35mm  
Photographer: Lisa Gracyzk  
Subject: Broken chemical bottles on  
road to chemistry storage building.

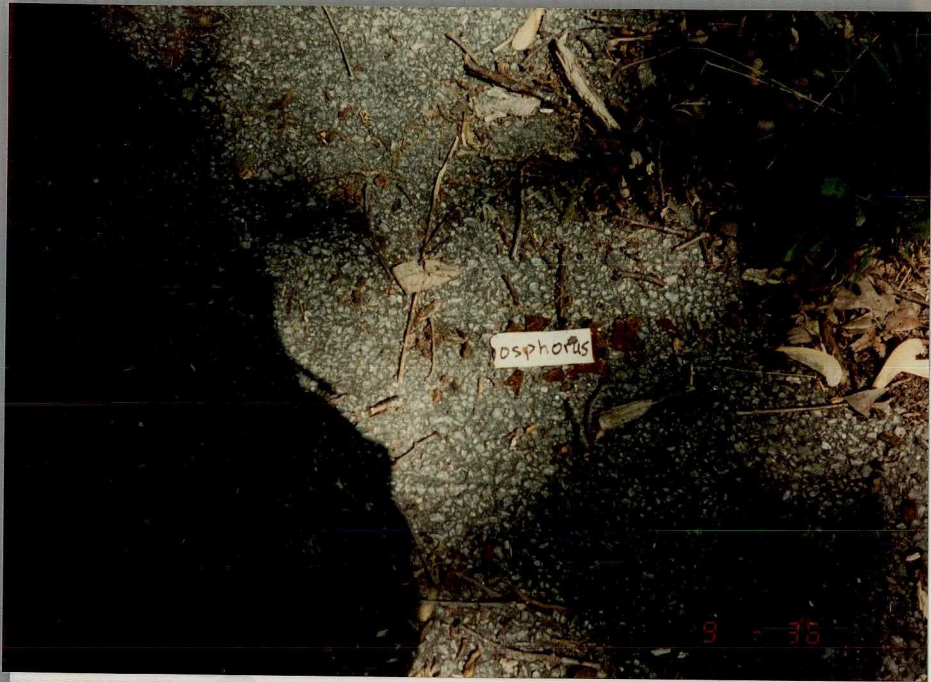
Site: Salesian Prep  
Photo No: 5 Date: 5/16/94  
Direction: North  
Camera: OLYMPUS INFINITY 35mm  
Photographer: Lisa Gracyzk  
Subject: Part of label found near  
broken bottle.

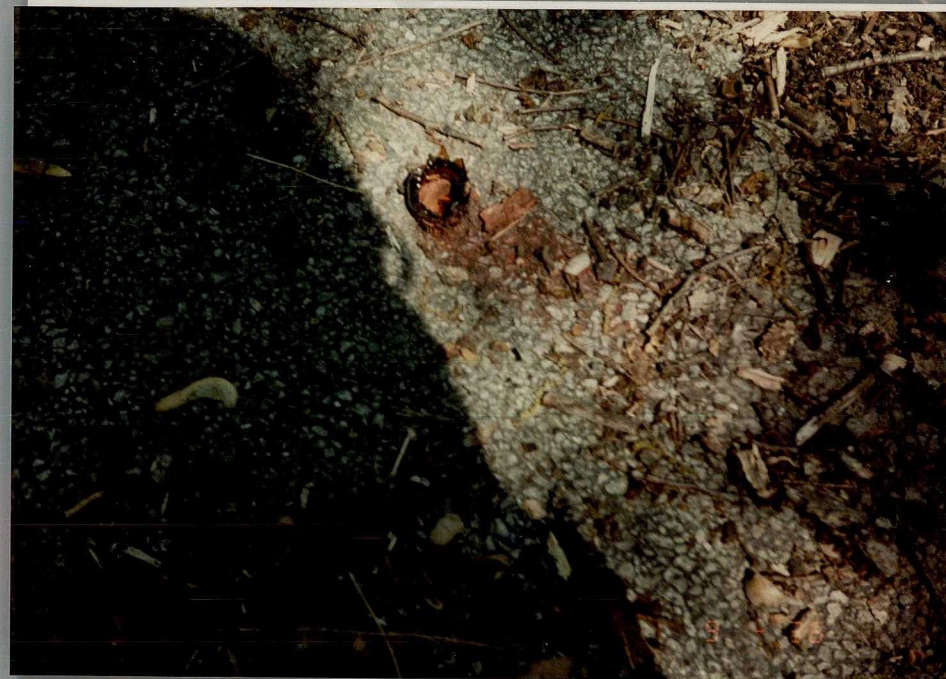
Site: Salesian Prep  
Photo No: 6 Date: 5/16/94  
Direction: South  
Camera: OLYMPUS INFINITY 35mm  
Photographer: Lisa Gracyzk  
Subject: Broken bottle and discolored  
area on gravel.

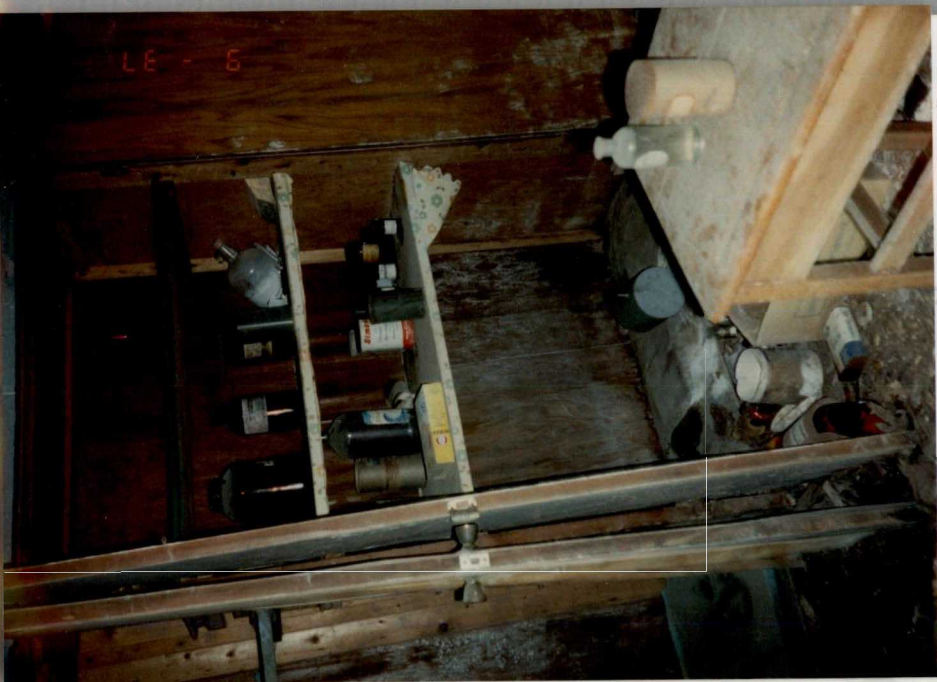
Site: Salesian Prep  
 Photo No: 7 Date: 5/16/94  
 Direction: North  
 Camera: OLYMPUS INFINITY 35mm  
 Photographer: Lisa Gracyzk  
 Subject: Chemical Storage Area.

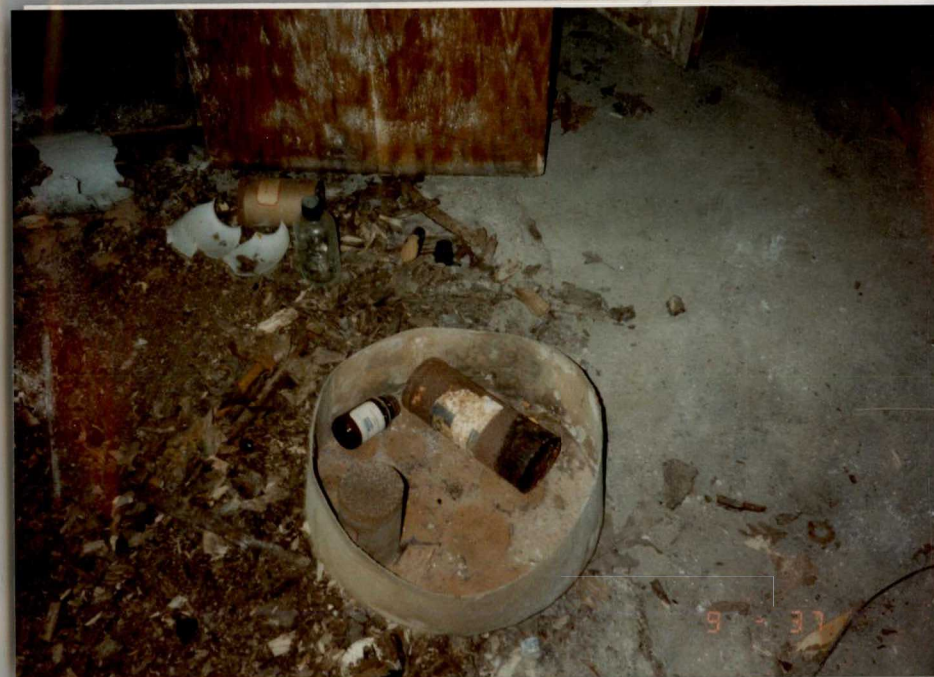
Site: Salesian Prep  
 Photo No: 8 Date: 5/16/94  
 Direction: North  
 Camera: OLYMPUS INFINITY 35mm  
 Photographer: Lisa Gracyzk  
 Subject: Chemical storage area.

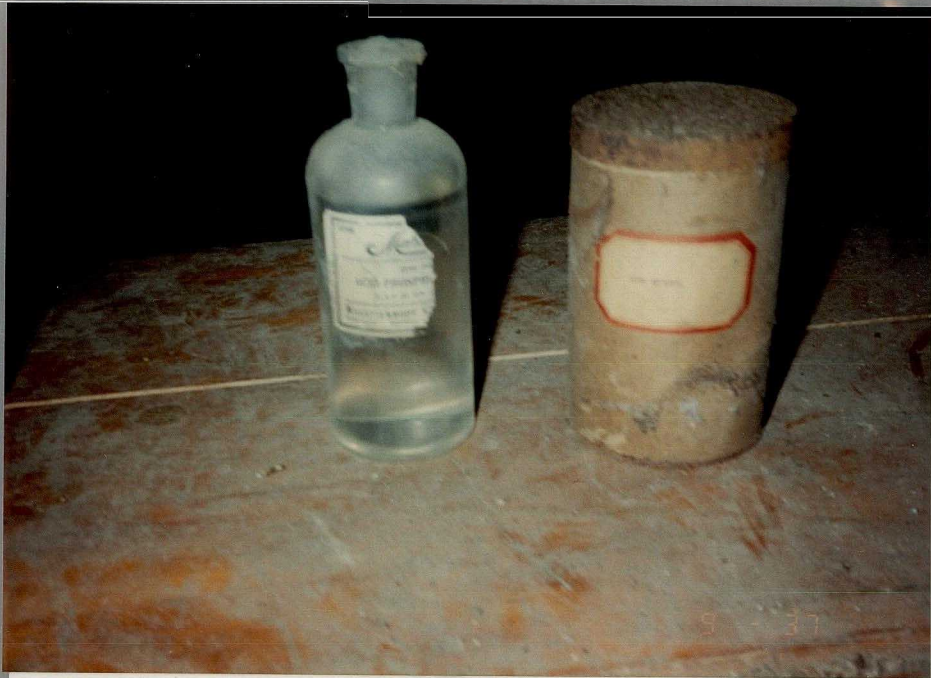
Site: Salesian Prep  
Photo No: 9 Date: 5/16/94  
Direction: East  
Camera: OLYMPUS INFINITY 35mm  
Photographer: Lisa Gracyzk  
Subject: Chemical containers on table  
in storage area.

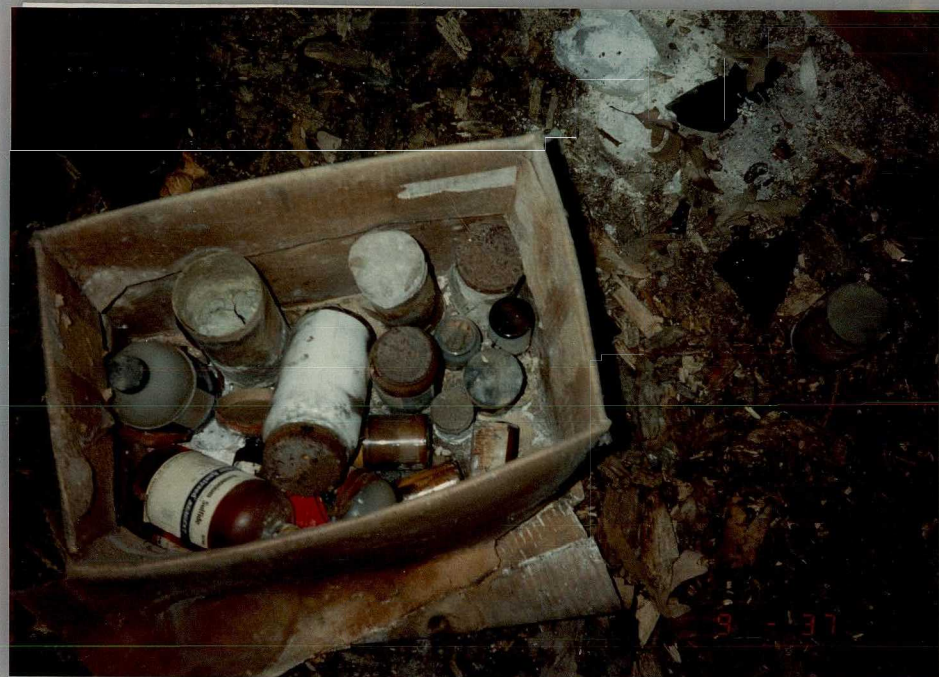
Site: Salesian Prep  
Photo No: 10 Date: 5/16/94  
Direction: East  
Camera: OLYMPUS INFINITY 35mm  
Photographer: Lisa Gracyzk  
Subject: Condition of chemicals in  
storage area.
